PROPERTY INFORMATION			
Street Address: 2623 Hugh St		# Bed: 2.0	Lot Size: 7250 Sq. ft.
City, State ZIP: Parkersburg, WV 26101		# Bath: 0.5	Living Area: 1248 Sq. ft.
APN:	# Units: 1	# Room: 0	Garage: No
Type: Siding	Access Code/Key:		
Other/Notes:			
The subject property sits at the back of its lot and has a very nice front yard with a parking area.

Subject Photos - 2623 Hugh St, Parkersburg, WV 26101

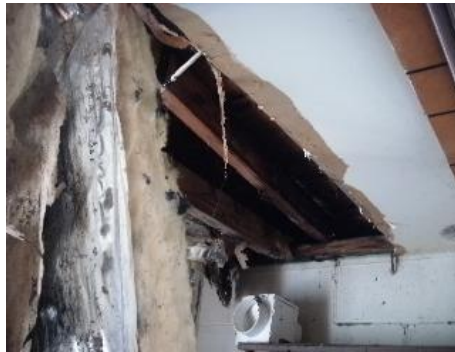
PROPERTY CONDITION			
Mold: Yes	Fire Damage: No	Water Damage: Yes	Roof Leak: Yes
Additional Information/Comments:			
The subject property has a lot of mold growing inside because of a roof leak. There is interior ceiling damage and the roof is tarped in the area where there was an apparent leak.			
Any Apparent Vandalism:			
none noted.			
Overall Condition:			
Fair. The subject needs the roof repaired. The big picture window in the front of the house is missing with plastic covering the hole. The kitchen and most of the flooring throughout the house needs updated. The property could also use some paint and patch in the interior.

ceiling in laundry area

Description	Est. Cost
roof repair	\$500.00
ceiling repair and mold removal (interior)	\$1,500.00
	\$0.00
	\$0.00
	\$0.00
	\$0.00
	\$0.00
	\$0.00
	\$0.00
	\$0.00
	\$0.00
Total Estimated Cost:	\$2,000.00
Any factors that will adversely affect marketability:	
The subjects roof condition and the growth of mold on ceiling and walls of the interior.

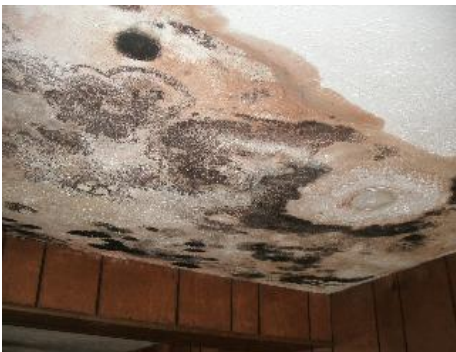
mold and ceiling damage in family room

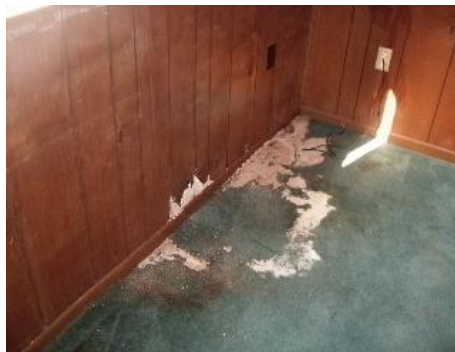
damaged and damp floor area in family room

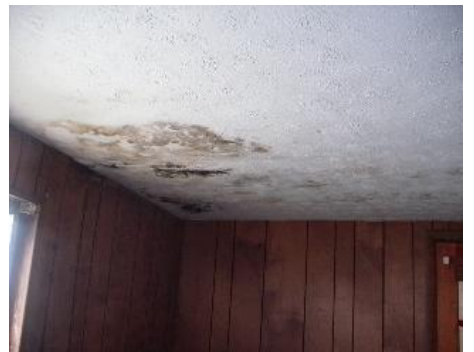
another ceiling damage area in family room

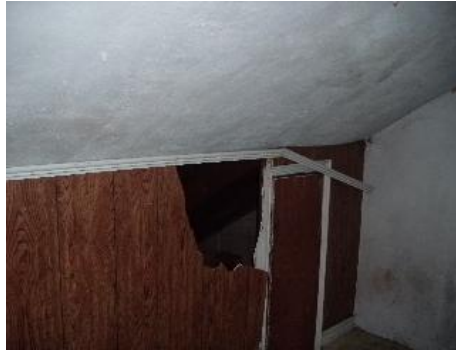
damaged area in 3rd bedroom

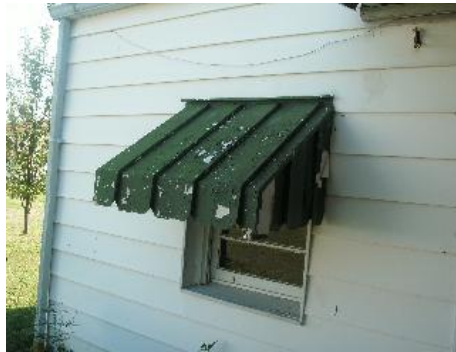
peeling paint on exterior awnings

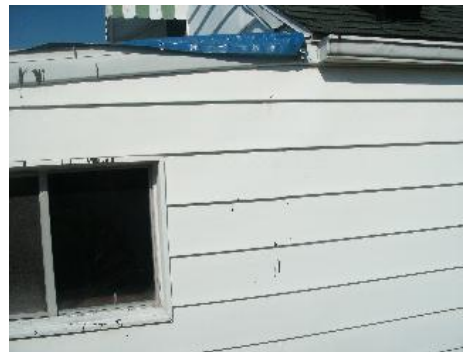
tarped roof
