PROPERTY INFORMATION			
Street Address: 2623 Hugh St		# Bed: 2.0	Lot Size: 7250 Sq. ft.
City, State ZIP: Parkersburg, WV 26101		# Bath: 0.5	Living Area: 1248 Sq. ft.
APN:	# Units: 1	# Room: 0	Garage: No
Type: Siding	Access Code/Key:		
Other/Notes:			
The subject property sits at the back of its lot and has a very nice front yard with a parking area.

Subject Photos - 2623 Hugh St, Parkersburg, WV 26101

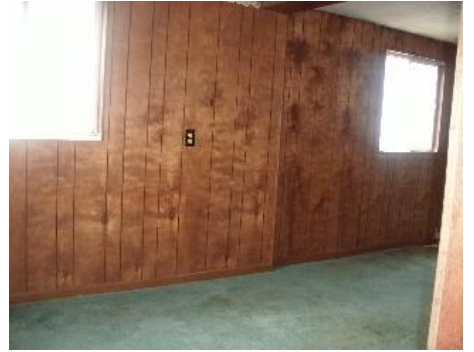
family room

PROPERTY CONDITION			
Mold: Yes	Fire Damage: No	Water Damage: Yes	Roof Leak: Yes
Additional Information/Comments:			
The subject property has a lot of mold growing inside because of a roof leak. There is interior ceiling damage and the roof is tarped in the area where there was an apparent leak.			
Any Apparent Vandalism:			
none noted.			
Overall Condition:			
Fair. The subject needs the roof repaired. The big picture window in the front of the house is missing with plastic covering the hole. The kitchen and most of the flooring throughout the house needs updated. The property could also use some paint and patch in the interior.

Description	Est. Cost
roof repair	\$500.00
ceiling repair and mold removal (interior)	\$1,500.00
	\$0.00
	\$0.00
	\$0.00
	\$0.00
	\$0.00
	\$0.00
	\$0.00
	\$0.00
	\$0.00
Total Estimated Cost:	\$2,000.00
Any factors that will adversely affect marketability:	
The subjects roof condition and the growth of mold on ceiling and walls of the interior.
